The Floods of 2022

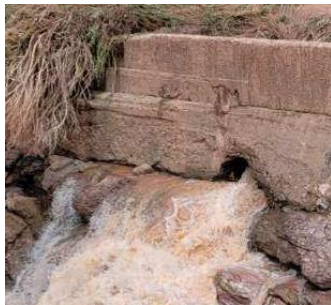
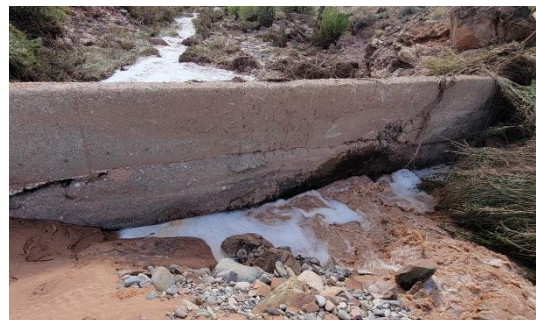
There had been several smaller floods this summer, then a very large one came down the creek on August 9th. This flood did two things. At the lower dam it flowed up and around the sides of the diversion dam a little bit and started to cut a small channel around the dam on the west side. At the upper dam, there is a

culvert built into the bottom of the dam. This culvert was put there to allow the creek to flow through while they built the dam. Well, the

flood opened this culvert up and all the creek water was flowing through it. First time we had ever seen the inside of the dam wall as no water was being backed up. A smaller flood several days later, silted the area back in and blocked the culvert again. **(The picture on the left shows the culvert location – the picture on the right is the inside of the dam. Dirty brown water in the lower right corner is flowing through the dam)**

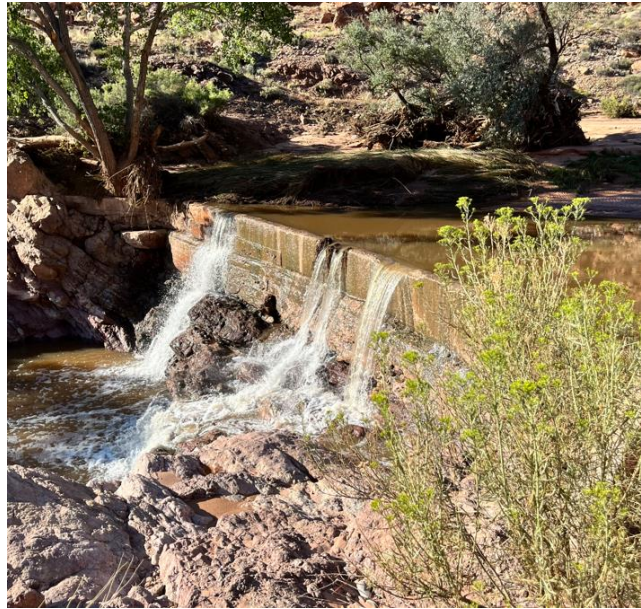
This flood caused extensive damage in the town. For the irrigation company we had damage too. The upper dam along Powerhouse Lane held up ok. Water flowed around the sides of the dam, but did not cause significant damage. Two concerns after the flood were that some of the side banking below the dam was washed away and just about exposed our underground pipeline. The flood also took three small divots out of the top of the dam. This may cause us a future problem. **(The picture shows the 3 divots in the top of the dam wall.)**

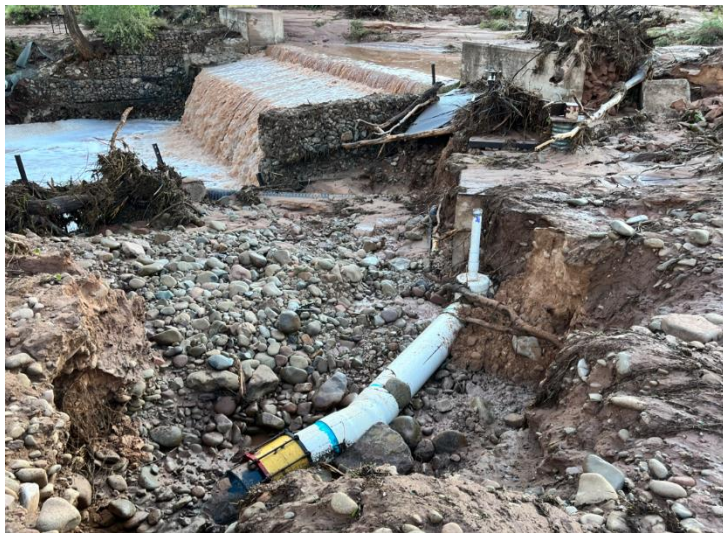
The lower main dam area experienced greater damage. Water also flowed around the sides of the dam. An inspection after the flood showed cover plates ripped off the Ditch 2 sand box area, damage to the rock gabion side wall of the dam, and the water had bored down FIVE feet in one area and exposed the Ditch 2 pipeline line. The flood then proceeded to break the Ditch 2 line and fill the

water measuring dip with mud and sand. The power of water can be so amazing. **(The picture shows the overall damage to the Ditch 2 side of the lower irrigation dam. Just past the yellow fitting, the pipeline drops 4' into short dip. This is done so the pipe is always full of water in the dip and then water flow measurements can be taken. This 4' dip was filled with sand/mud.)**

It took us over a week to repair the damage to the Ditch 2 pipeline and sandbox and get it flowing again. The rock gabion wall however is another story. Options are being looked at to see how to best repair the wall.

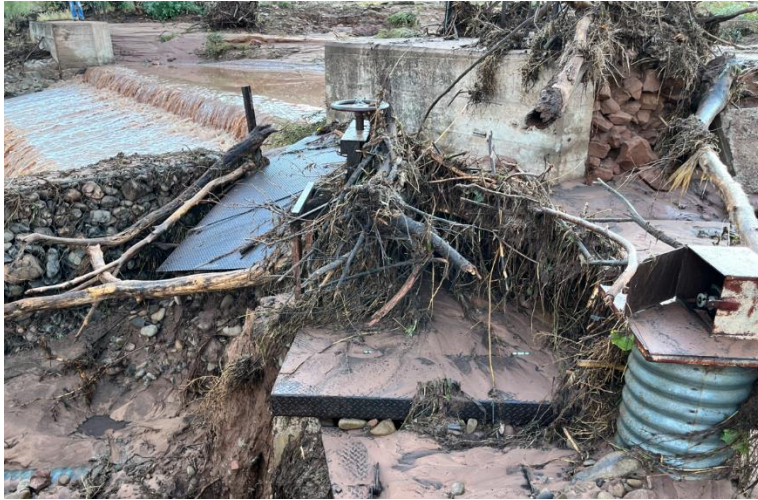
(The picture shows the Ditch 2 sandbox with heavy metal plates ripped off the top.)

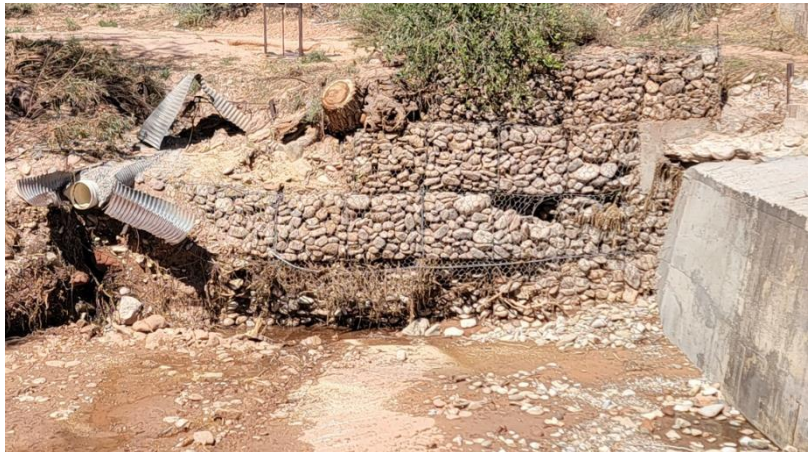
(The whole lower dam is made of rock gabions. You have the main section and two wings – one on each side of the creek. The east wing had suffered some small damage in previous floods over the years, but the Aug 20th flood really caused damage. The west wing held up ok.)
