## Highway 191 Line Replacement – Ditch 1

October, 2020

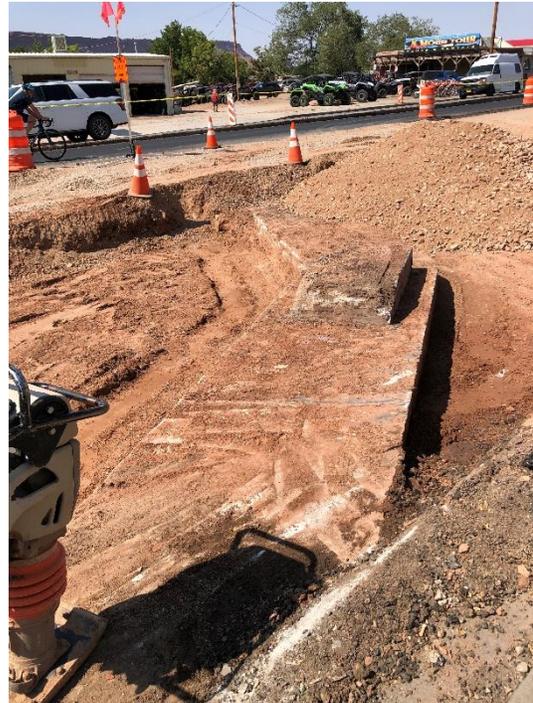
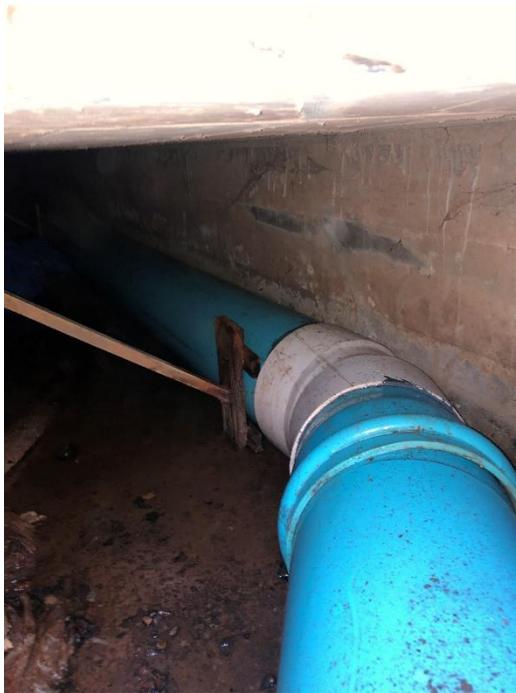
We did not expect any issues with this tunnel until the construction crew was rotor-milling up the old asphalt in the east side lane and the machine ran into an access box that was installed on the top of the

tunnel.

The access box was only a couple inches below the asphalt. Apparently, this was acceptable back when it was built, but the engineers for this recent upgrade were concerned as the box was too high and the quality of the cement work was in question.

After much discussion with the UDOT engineers it was finally decided to remove part of the tunnel on the east end, but leave the tunnel in place the rest of the way under the road. Originally, they thought to remove the whole tunnel, but they found that it was built much stronger than they realized. They did though want to flow fill cement into each end of the tunnel.

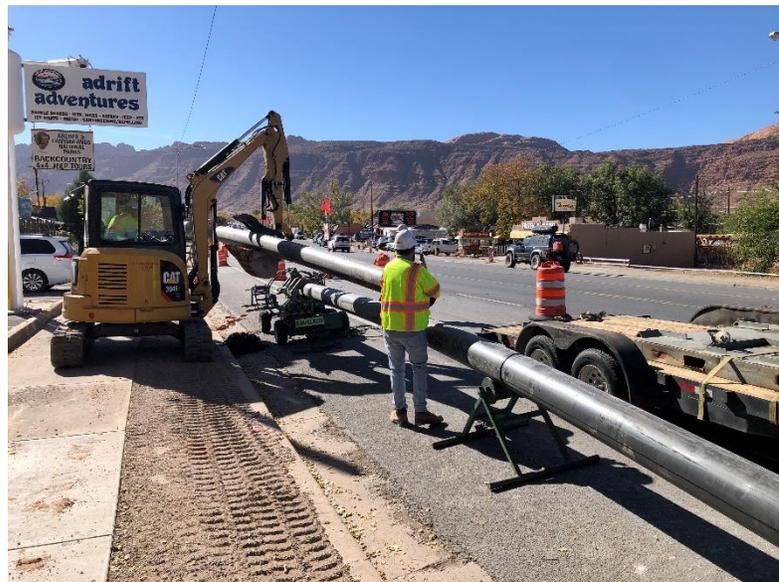
Looking inside the tunnel from the access box we could see our pipe line and we also discovered that the tunnel was not a straight shot across the highway. It actually made a 30° bend. The tunnel was found to go from

the east side of the sidewalk on the east side, to the west side of a drive way on the west side. About 100' long.

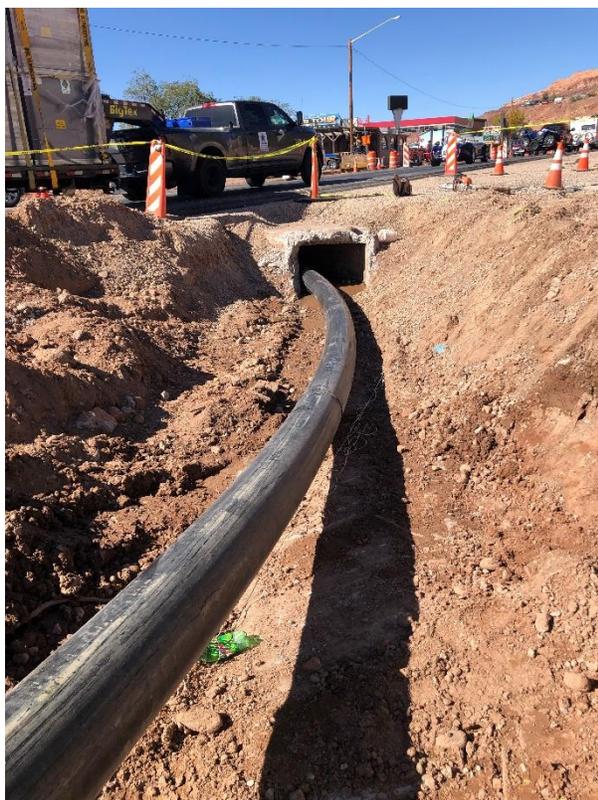
The company decide that to do this the line needed to be upgraded to tougher HDPE pipe so that it should never have an issue in the future. The PVC pipe inside the tunnel looked to already be leaking some water and the connection at the 30° bend was barely holding together.

So, the company bought 120' of 10" HDPE pipe and had it welded together on the side of the road. Then in a nice warm afternoon when the pipe was hot, a cable was ran through the tunnel and the old PVC pipe removed and the new HDPE pipe pulled into the tunnel. The challenging part was that the heavy pipe had to make a 30° bend as it was pulled through the tunnel and to make the connection on the east end. That is why it had to be done after the pipe had been sitting in the sun for a while.

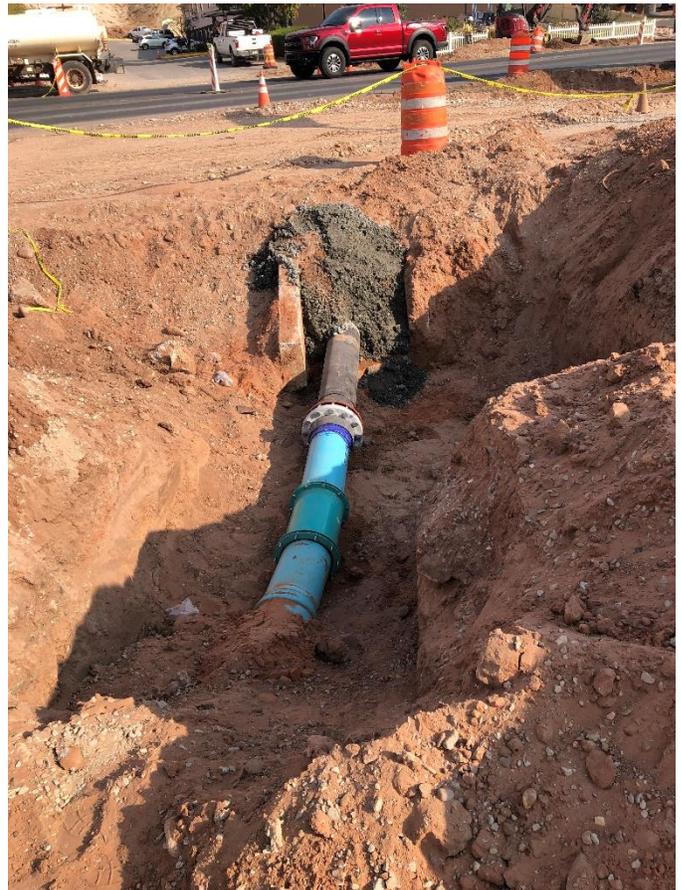
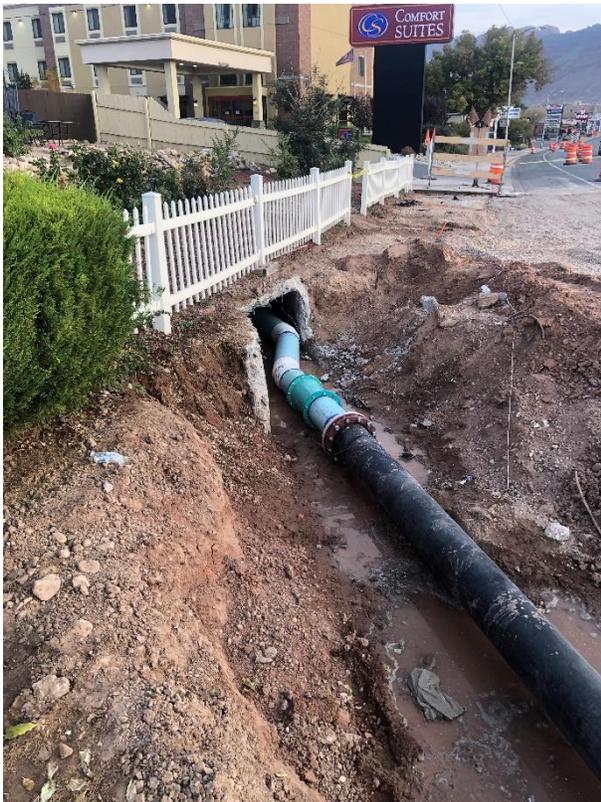
Then the HDPE pipe was connected at both ends to the 10" PVC pipe still in the ground. All this was done with heavy traffic crossing over the tunnel in the middle lanes of the road.
