Mill Creek Floods

In 2006, the water master took pictures of what can happen during a Mill Creek Flood. These pictures were taken at the lower diversion dam.

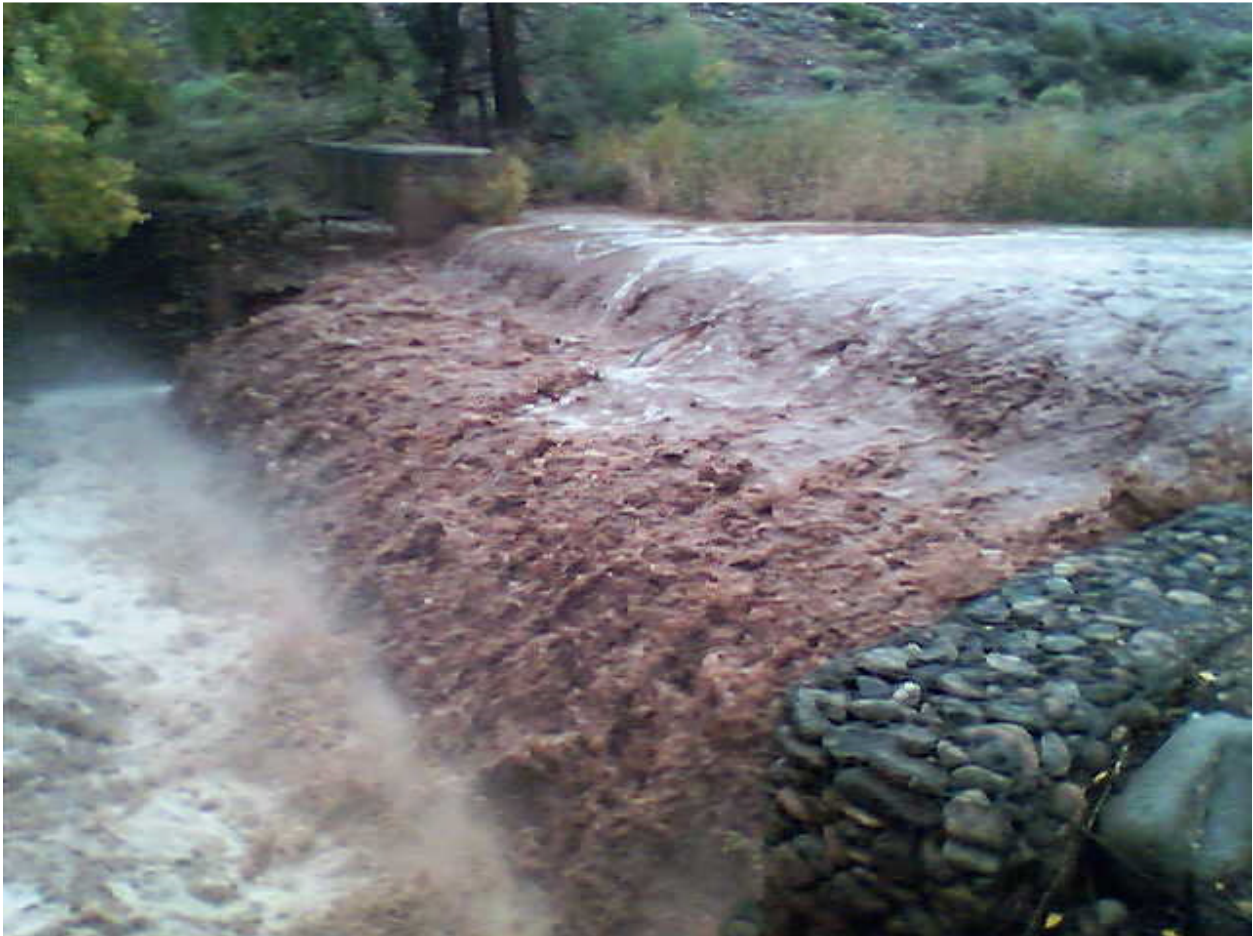
The water was coming hard and fast. It looked like a set of Colorado River rapids. This flood was larger than normal. Some damage occurred to the base of the dam.

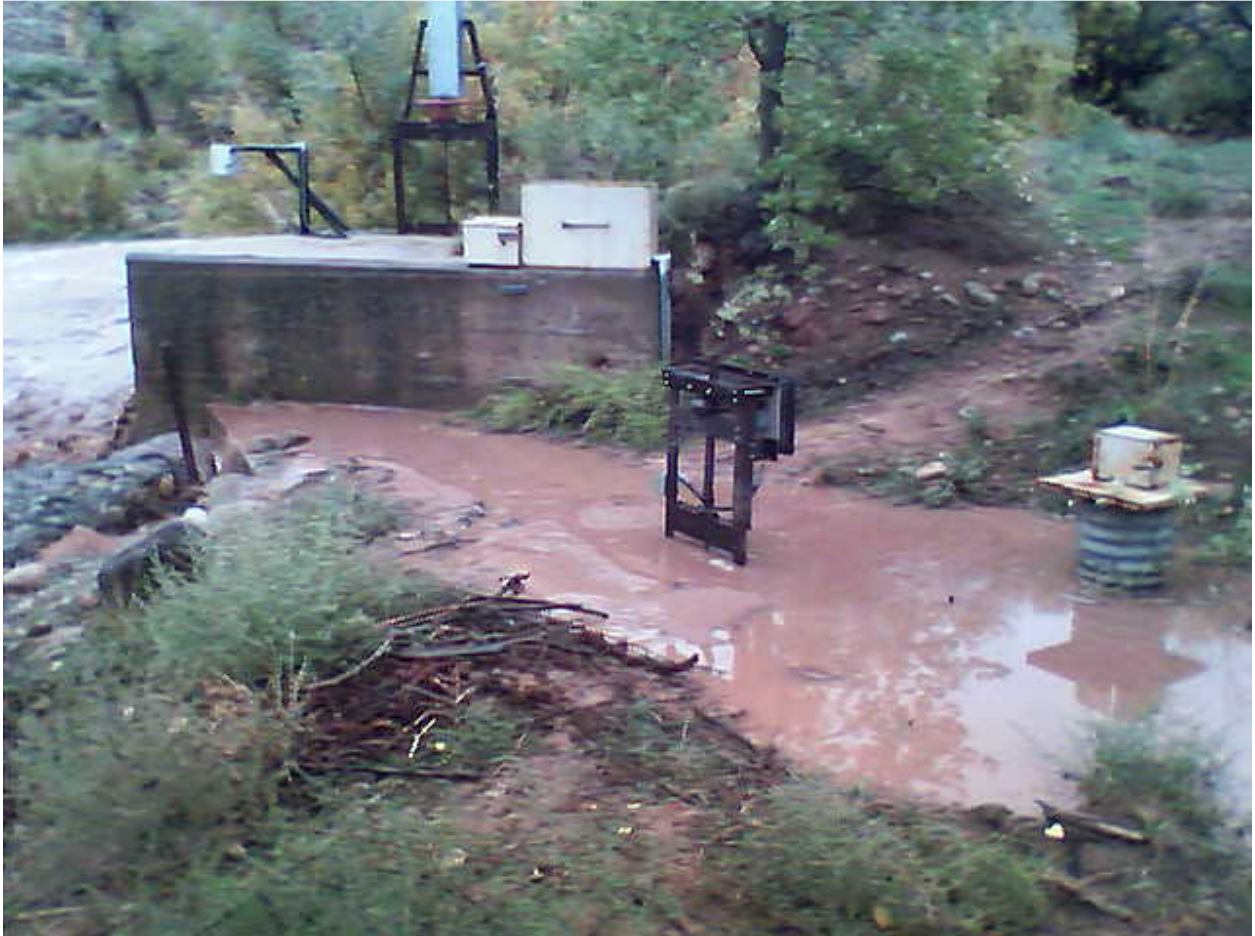
Water flowed around and over the sand box of Center Ditch 2 and it filled the sand box with sand, it plugged the exit pipe that allows water to go back into the creek and it put a fair amount of sand into the main irrigation pipeline that had to eventually be flushed out.

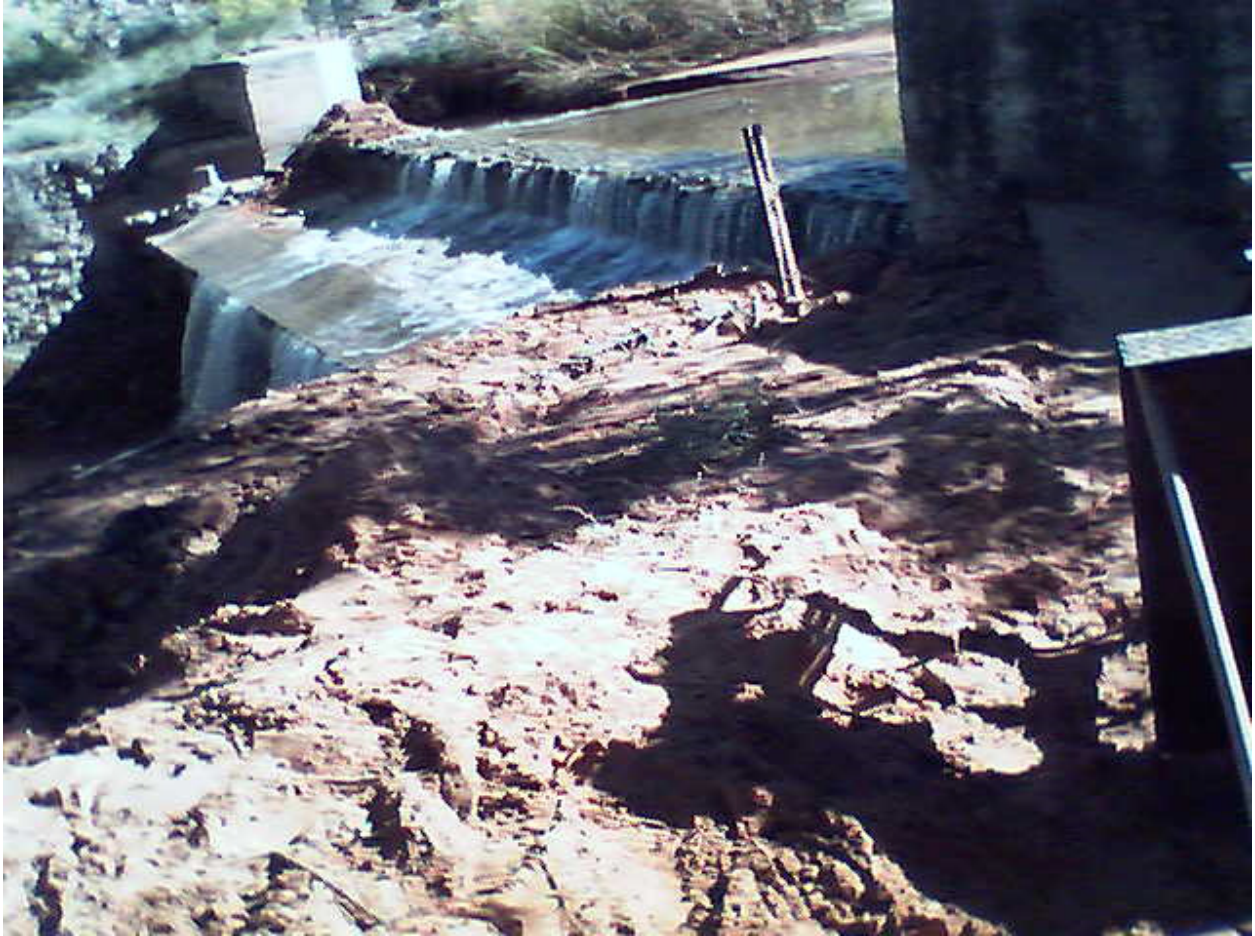
A lot of sand was deposited inside and on top of the sand box for Center Ditch 2. It took several days and a large water truck to clean the sand off and out of the system. Shareholders often do not know what the water master deals with behind the scenes to keep the water flowing in the irrigation system.
